# TEST FLIGHT

My name is Thom Iannarino: I am an Army Major Retired and a Master Aviator. I flew over 1300 combat hours in the Republic of Vietnam (RVN) during my tours with the 1<sup>st</sup> Cavalry Division in 1967-68 and the 1<sup>st</sup> Aviation Brigade in 1969-70. The incidents you are about to read and view occurred during my second tour.

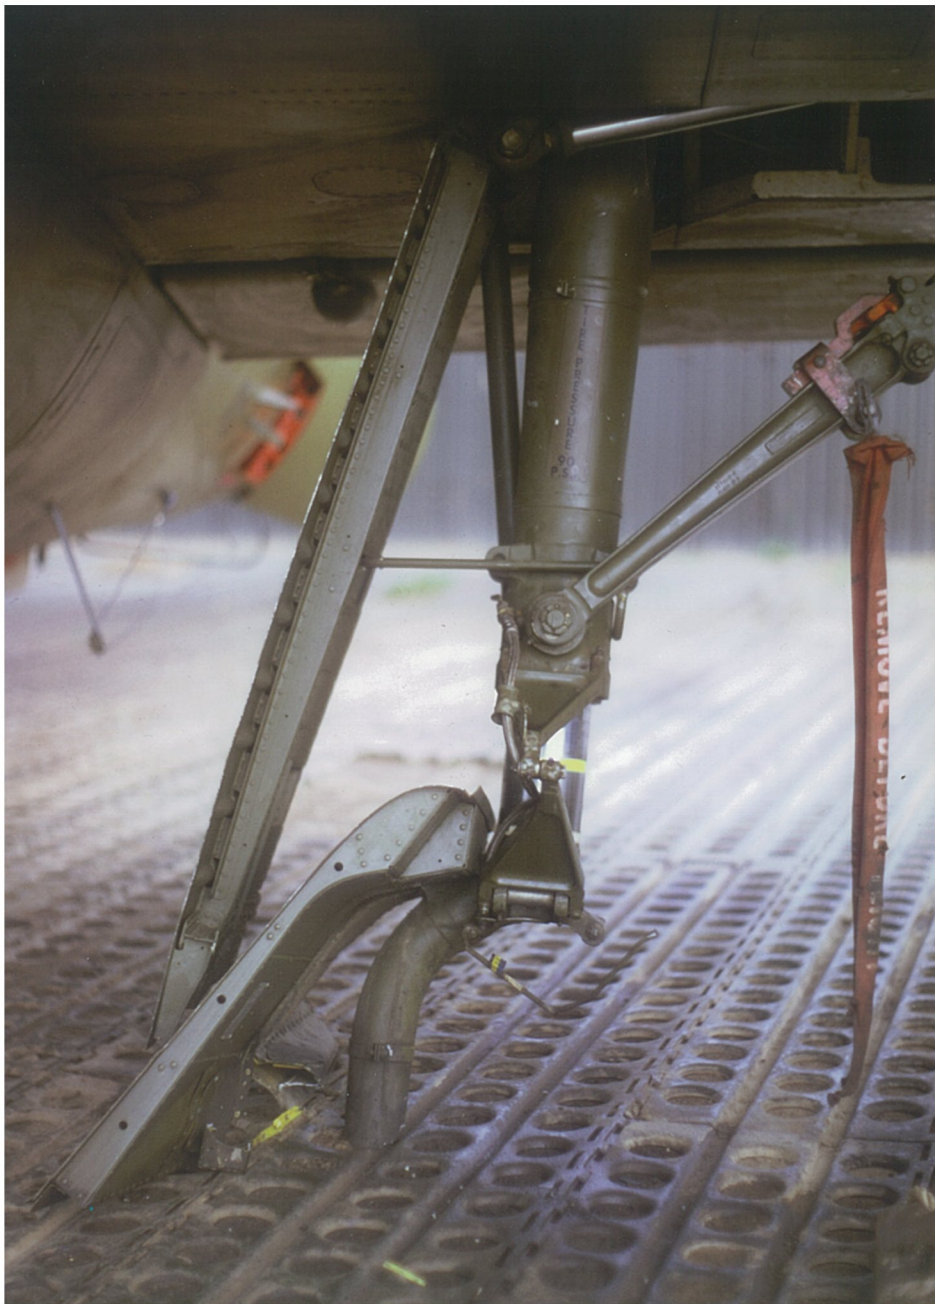
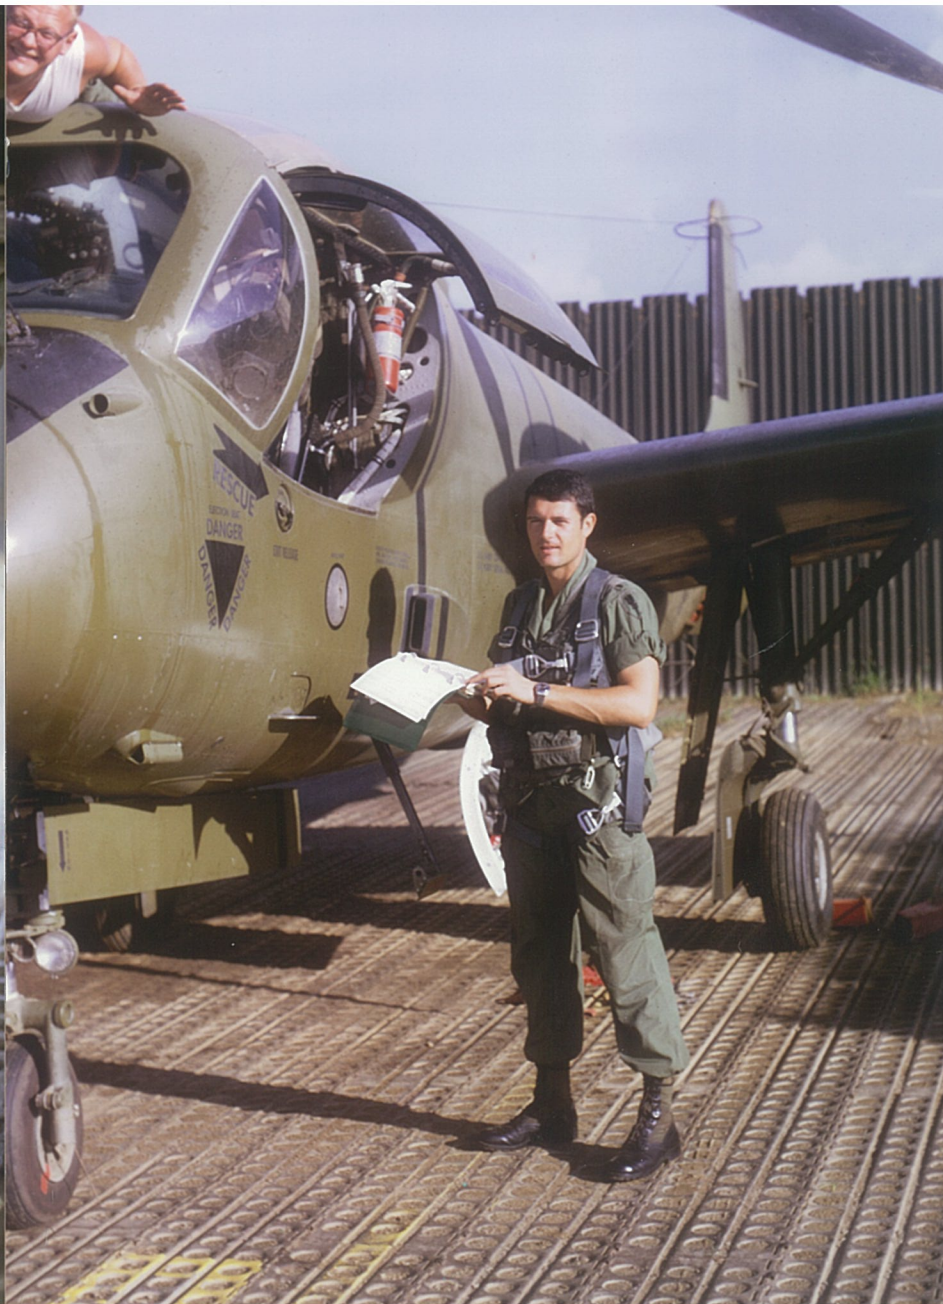
I immediately left the office to where 697 was parked. I could not believe my eyes. The left main landing gear was broken at the inside of the wheel just above the axle spindle. I just stood there for what seemed an eternity thanking God that the break did not occur on my landing. I could have been, at a minimum, seriously injured and the aircraft totally destroyed. A broken gear strut would not have fared well going down and along the PSP runway.

- 6 When I recovered from my initial shock as to what could have been, I took a close look at the gear strut. All sorts of questions entered my mind to include: "Was my last landing on the test flight a hard landing?" (After conferring with my tech observer on the flight, we agreed it wasn't a hard landing.) "When was there a hard landing?" "Was there ever a hard landing?" "Was this incident a result of metal fatigue?"
- 7 As I rolled all these questions in my mind, I returned to my flight line office and took the logbook for 61-2697 and entered a RED X on Form 2408-13 grounding the aircraft due to a broken left main landing gear.

To this day I do not know why the gear broke. I submitted paperwork, pictures, etc but I never received an answer. I just thank God no one and nothing else was broken
