OV-1 EVAC

Another of my responsibilities as the 244th aircraft maintenance officer was to evacuate damaged OV-1's. One means of doing this was by the use of the CH-54 Tarhe helicopter. It was the only helicopter at the time capable of lifting the 15,000 pound Mohawk.

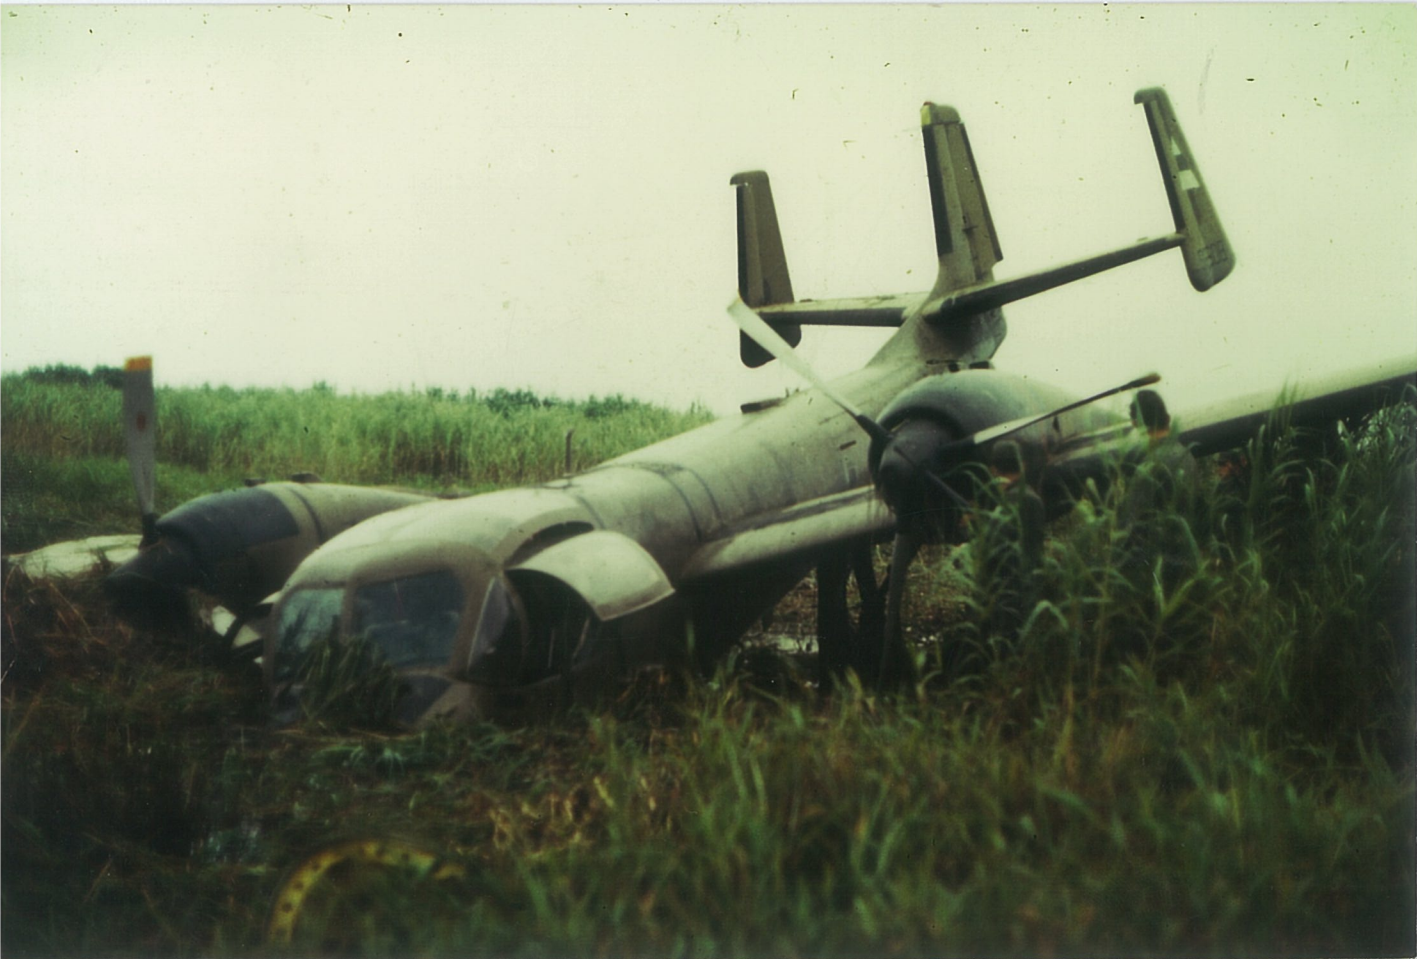
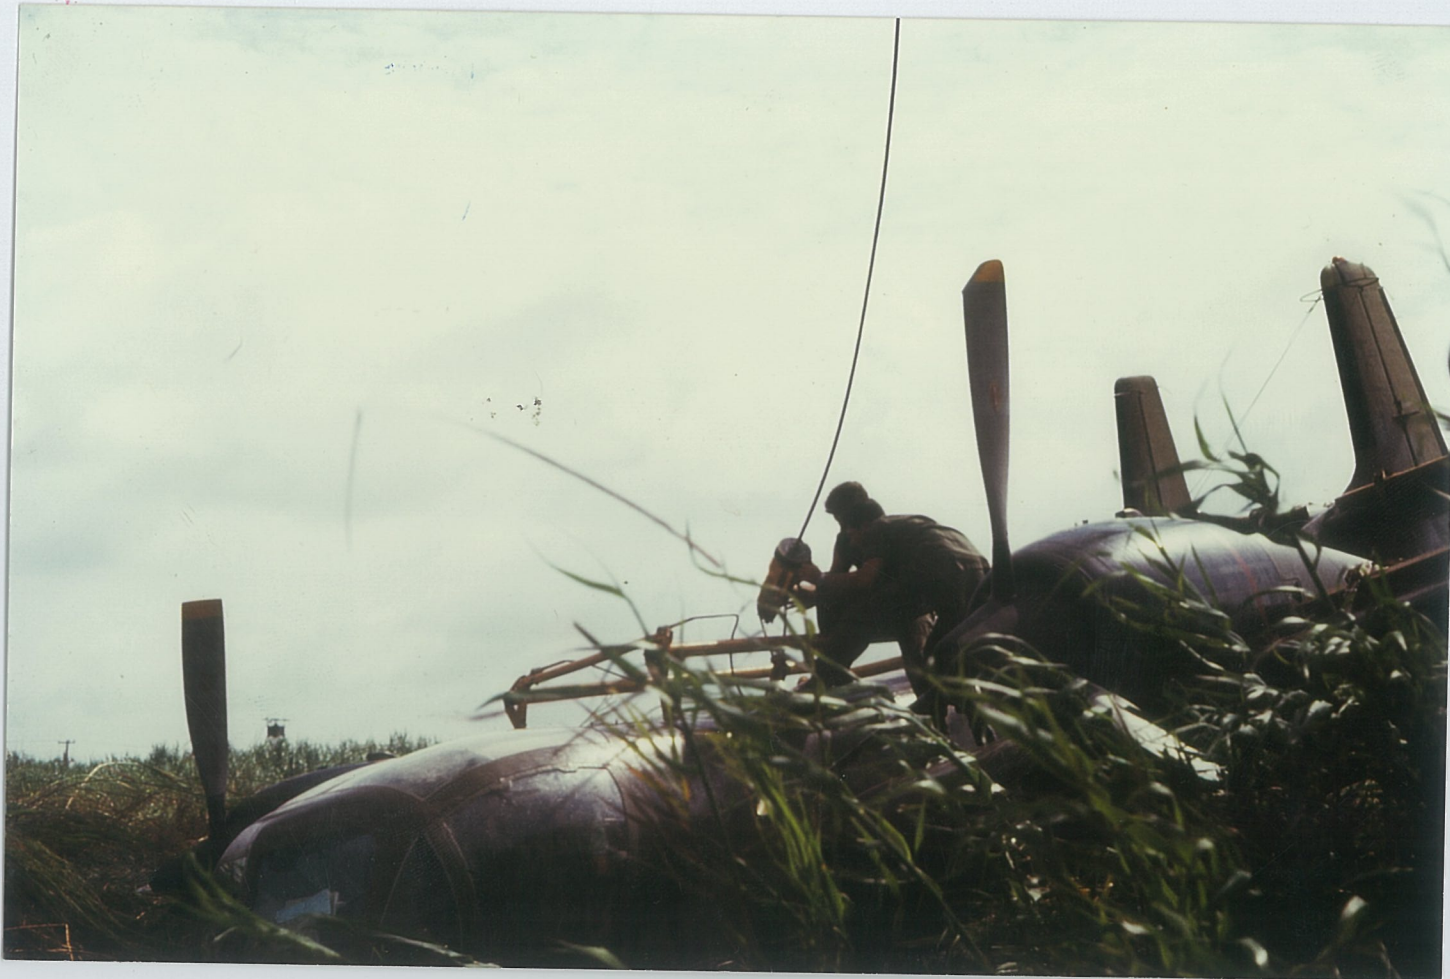
Depicted in the following photos is the sequence of events in the air evacuation of OV-1C 59-2608. Photos 1 and 2 show the Mohawk nose down in a water filled canal. This accident was the result of a pilot landing long on a wet perforated steel planking (PSP) runway, running off the runway's end, over a dirt road, and into the canal.

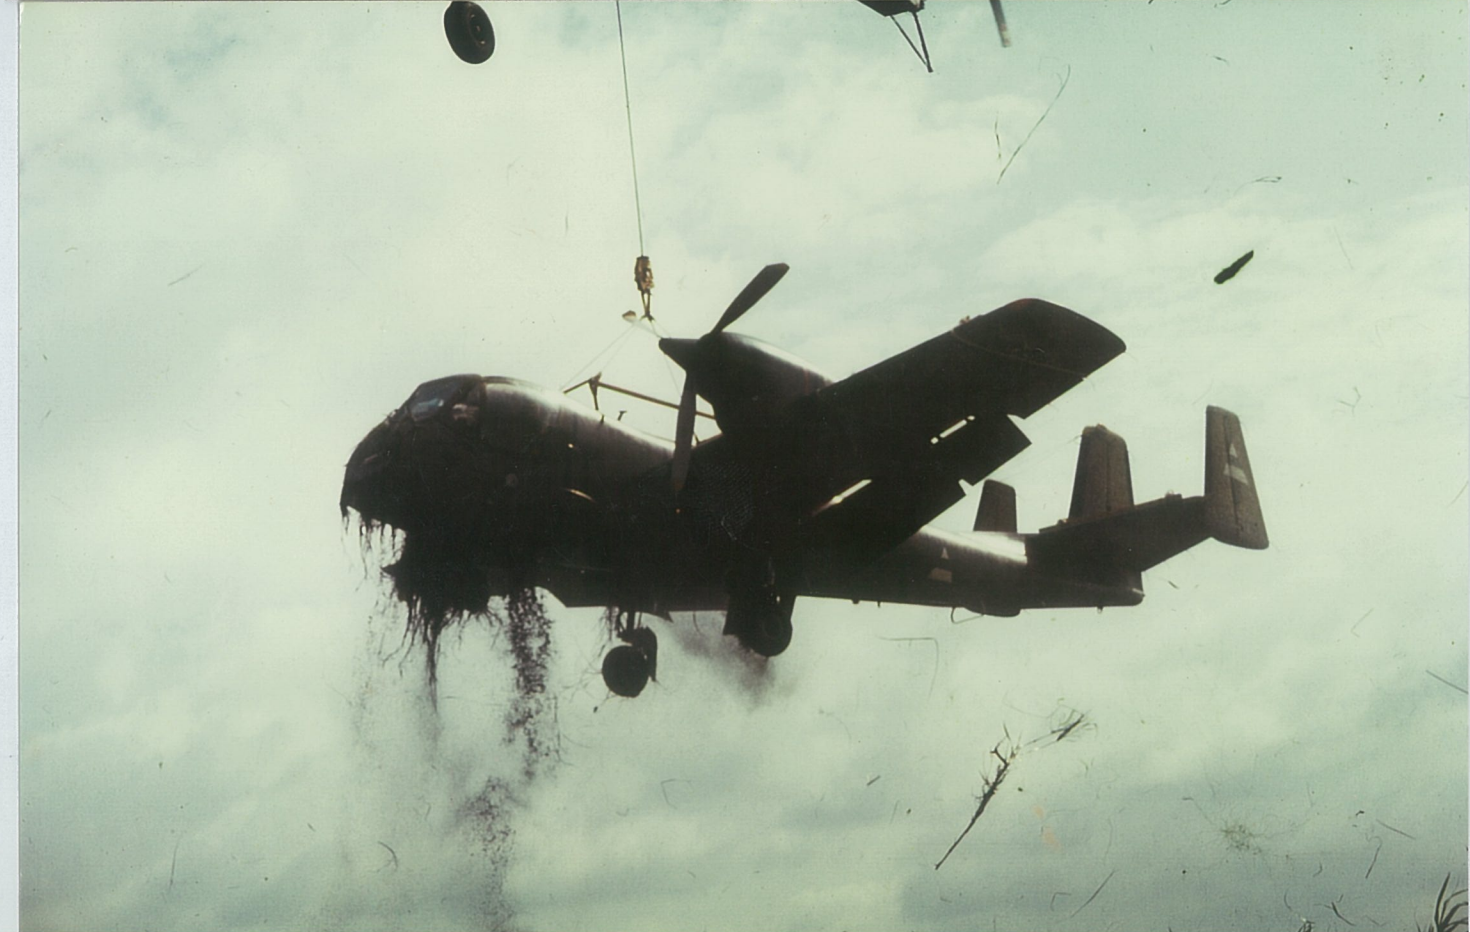
Initially the CH-54 could not extract the OV-1 straight up out of the water. The helicopter had to hover behind the Mohawk and gently back it out a couple feet at which time the suction effect was broken. The plane was then lifted up several feet. It took about 10 minutes for enough water to drain out of the flooded compartments before the nose took a level attitude. The CH-54 and OV-1C 59-2608 were then able to depart as shown in photo 8.
