# TEST FLIGHT

My name is Thom Iannarino: I am an Army Major Retired and a Master Aviator. I flew over 1300 combat hours in the Republic of Vietnam (RVN) during my tours with the 1<sup>st</sup> Cavalry Division in 1967-68 and the 1<sup>st</sup> Aviation Brigade in 1969-70. The incidents you are about to read and view occurred during my second tour.

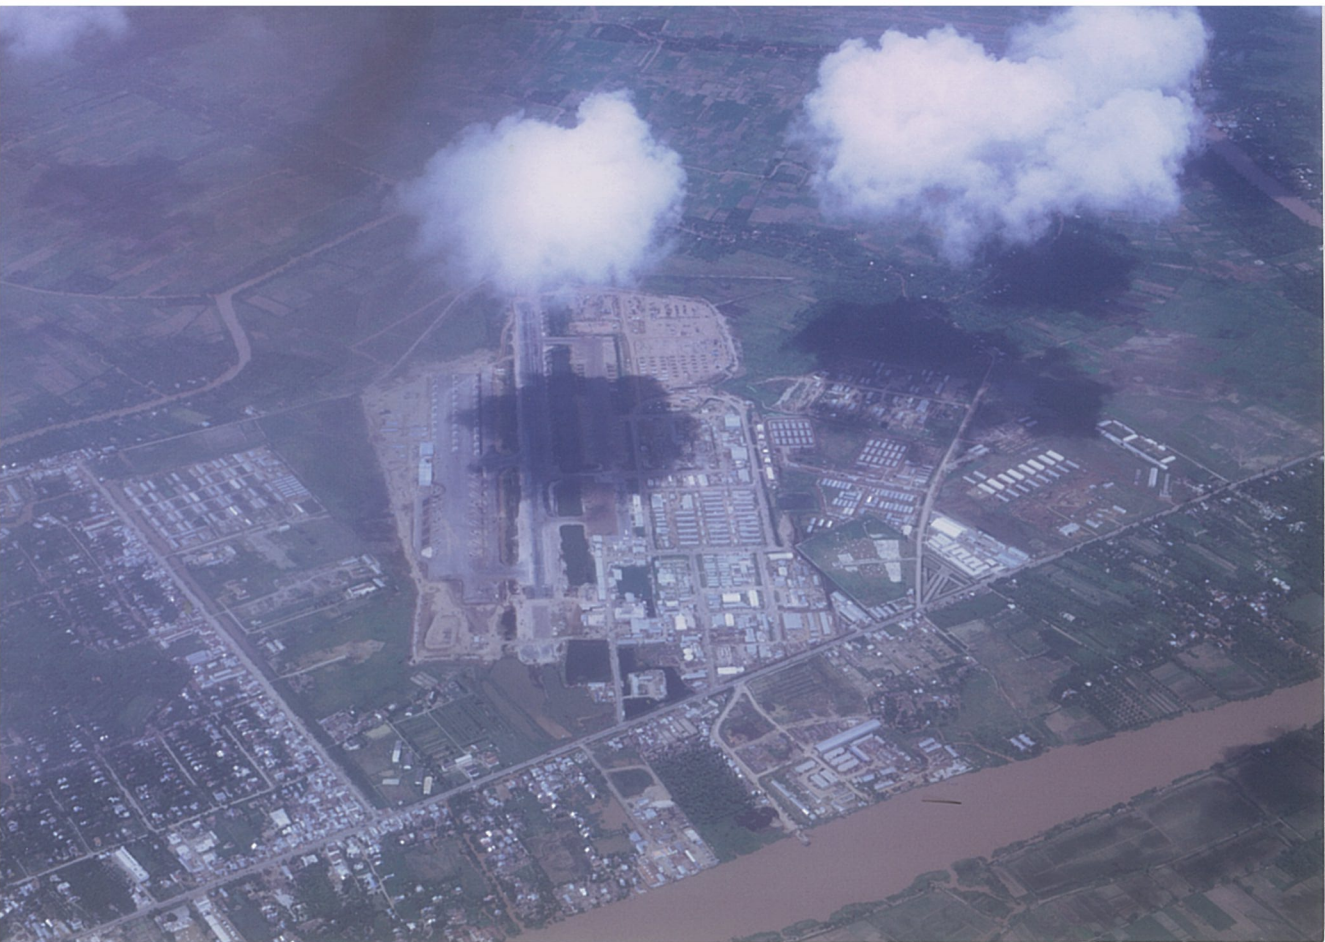
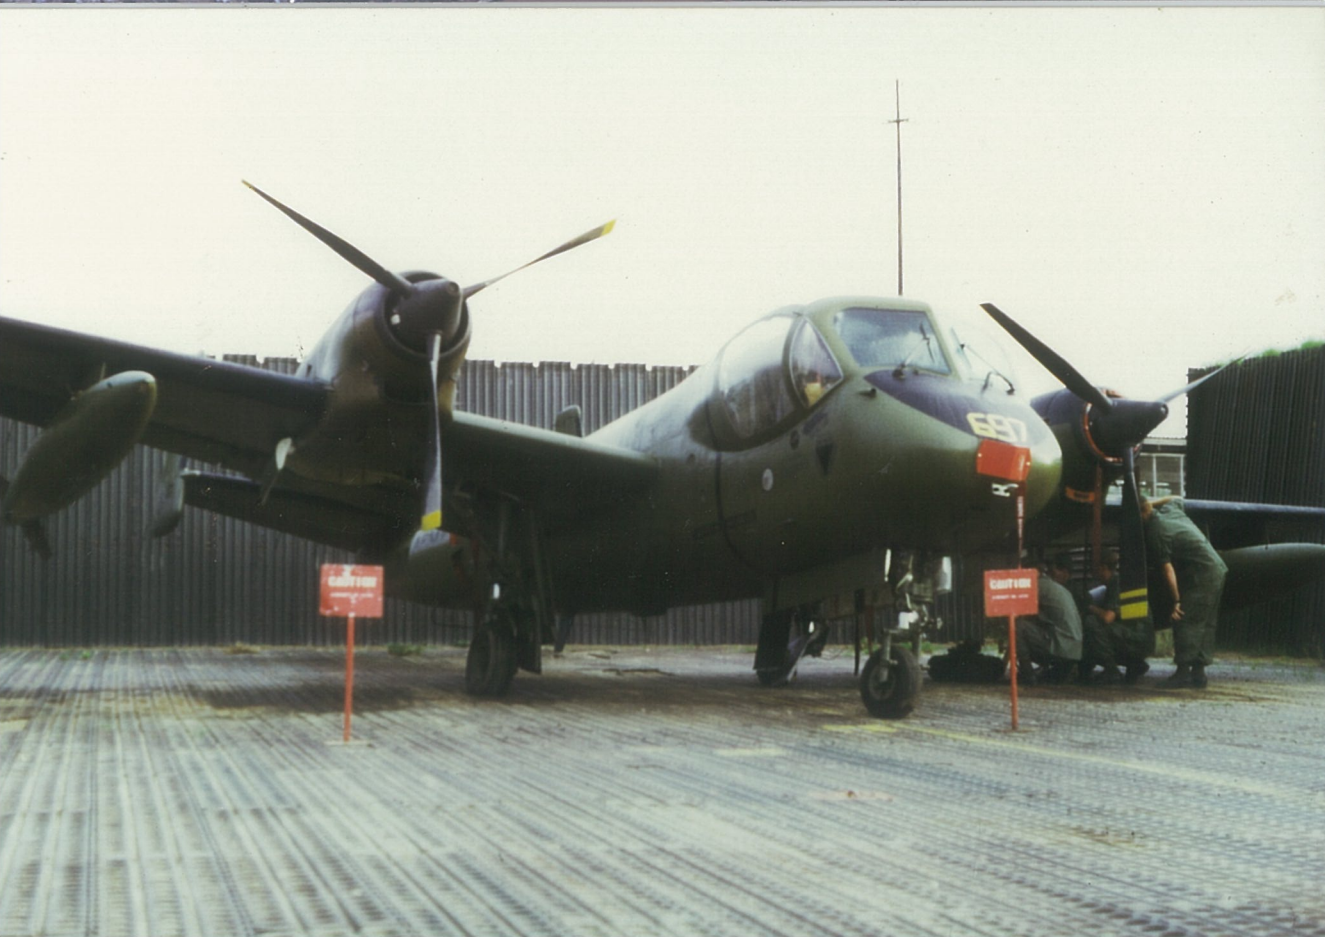
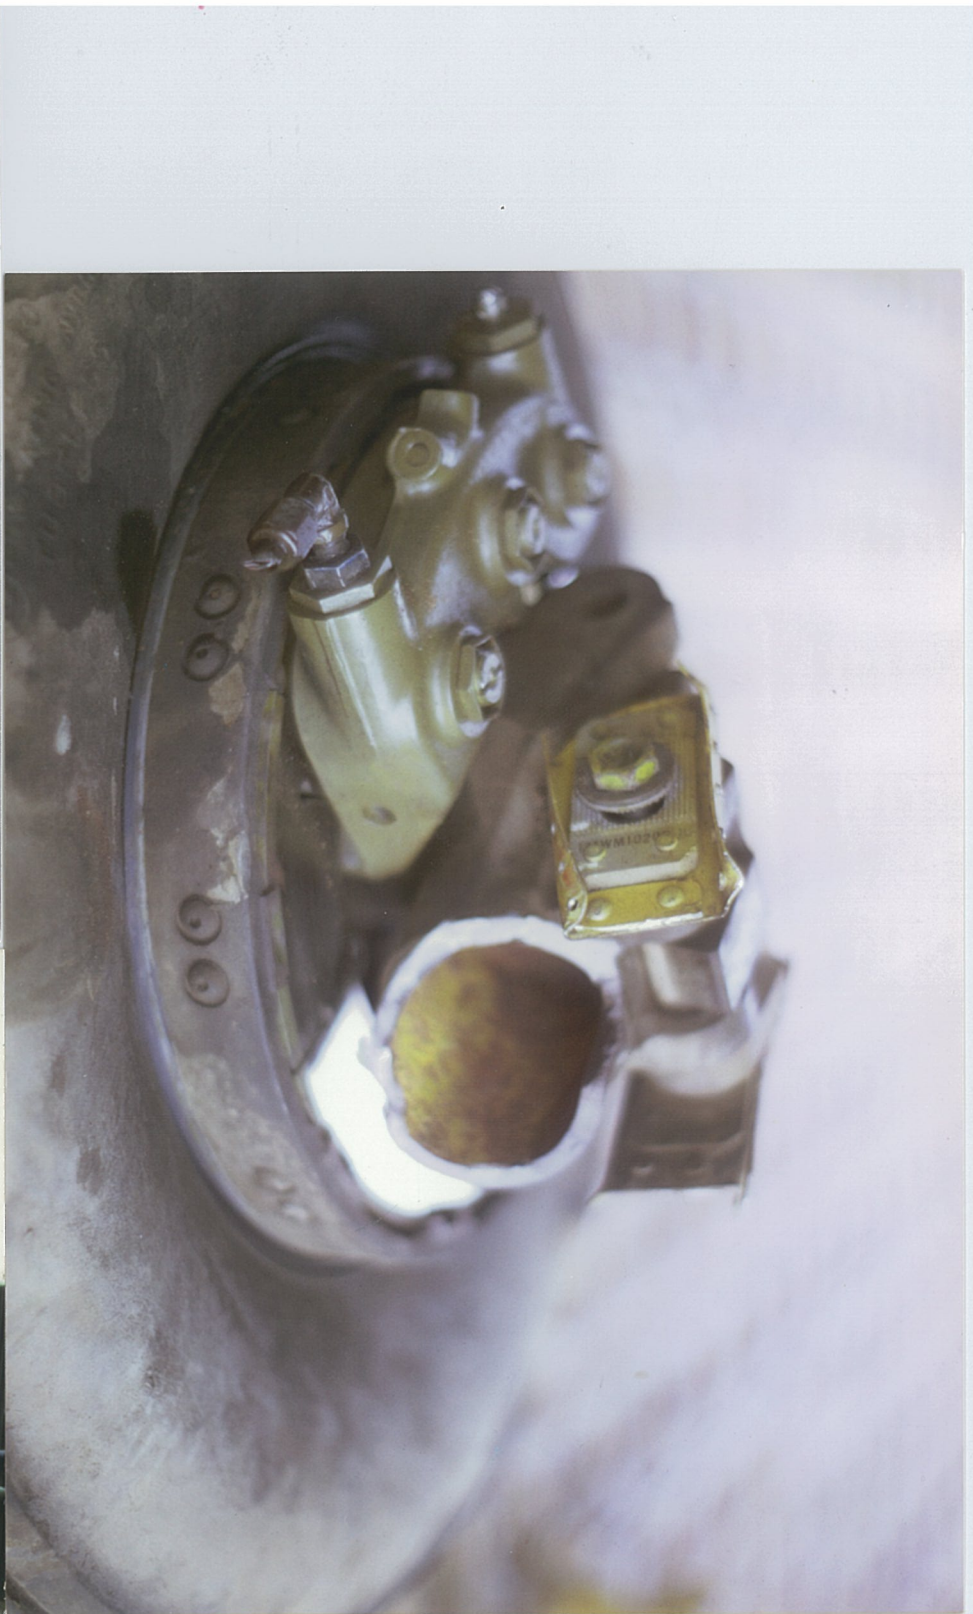
I immediately left the office to where 697 was parked. I could not believe my eyes. The left main landing gear was broken at the inside of the wheel just above the axle spindle. I just stood there for what seemed an eternity thanking God that the break did not occur on my landing. I could have been, at a minimum, seriously injured and the aircraft totally destroyed. A broken gear strut would not have fared well going down and along the PSP runway.

- 6 When I recovered from my initial shock as to what could have been, I took a close look at the gear strut. All sorts of questions entered my mind to include: "Was my last landing on the test flight a hard landing?" (After conferring with my tech observer on the flight, we agreed it wasn't a hard landing.) "When was there a hard landing?" "Was there ever a hard landing?" "Was this incident a result of metal fatigue?"
- 7 As I rolled all these questions in my mind, I returned to my flight line office and took the logbook for 61-2697 and entered a RED X on Form 2408-13 grounding the aircraft due to a broken left main landing gear.

To this day I do not know why the gear broke. I submitted paperwork, pictures, etc but I never received an answer. I just thank God no one and nothing else was broken
